Baseline and Environmental Impact Assessment for Proposed Eskom Kilbarchan Water Treatment Plant, Newcastle, KwaZulu-Natal Province

Soil, Land Use and Land Capability Assessment Report

ESK5108

April 2020

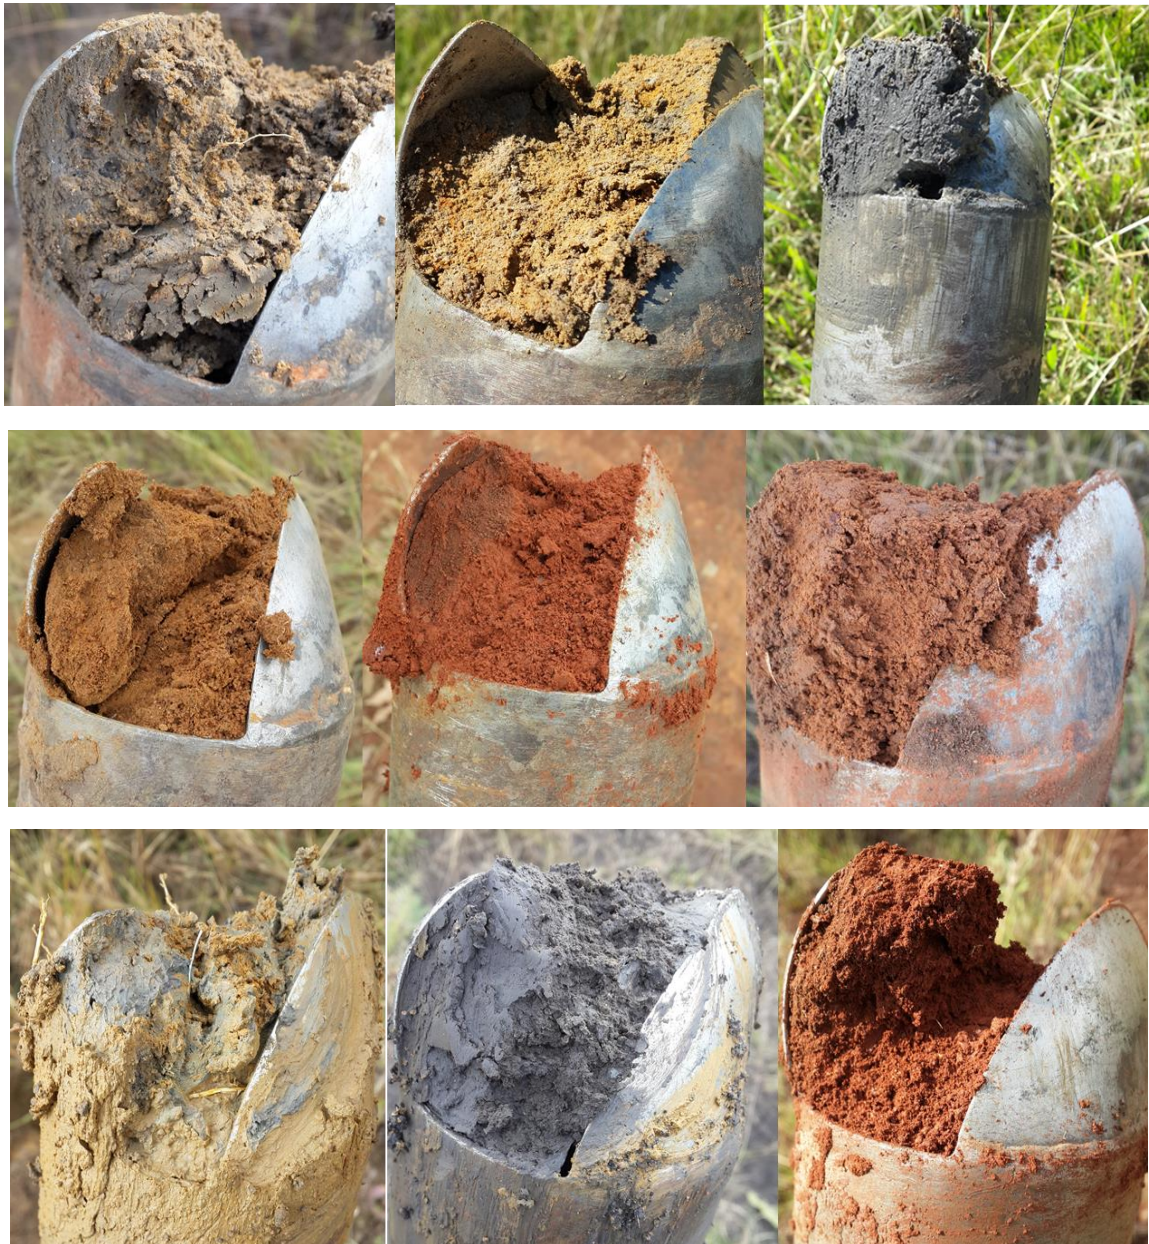
Figure 9-5: Examples of Soils Found on the Site (Red apedal, yellow brown and dark brown soils)

The finding of the soil assessment suggested that the land type associated with the project area was dominated by land types Ac, Bb, Dc and Ea. The soils are dominated by Clovelly and Longlands forms (yellow-brown), Hutton forms (red apedal) and (black and greyish) Arcadia forms. The dominant land capabilities based on the soils, texture and fertility status found on the project area was grazing. Yellow brown soils are known to be highly susceptible to water or wind erosion, very slow permeability of the subsoil, low water-holding capacity and moderate salinity or sodicity. Wetland areas are characterised by Arcadia soils. Although these soils are deeper, they have high expansible clay content and are physically difficult to manage.
